Info Sheet Understanding Water Quality in the SEAWA Watershed

2017—1

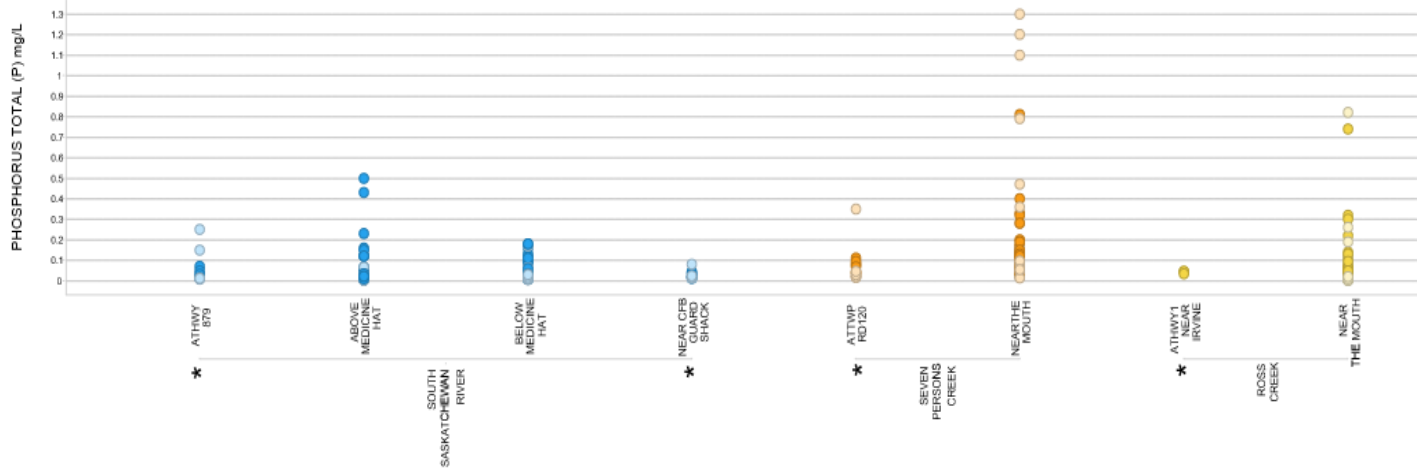
Total Phosphorus concentration (mg/L) at different locations in the South Saskatchewan River, and Seven Persons and Ross Creeks (2011-2016; *2015-2016); light circles are ice season and dark circles are open season data. Generally accepted total phosphorus concentrations greater than 0.05 mg/L may pose a risk of eutrophication. Graph provided by Alberta Environment and Parks.

Water Quality information over time is compiled and summarized as graphs (an example below). Summarizing information shows patterns that provide awareness about water quality issues or potential issues, and direction towards management actions.

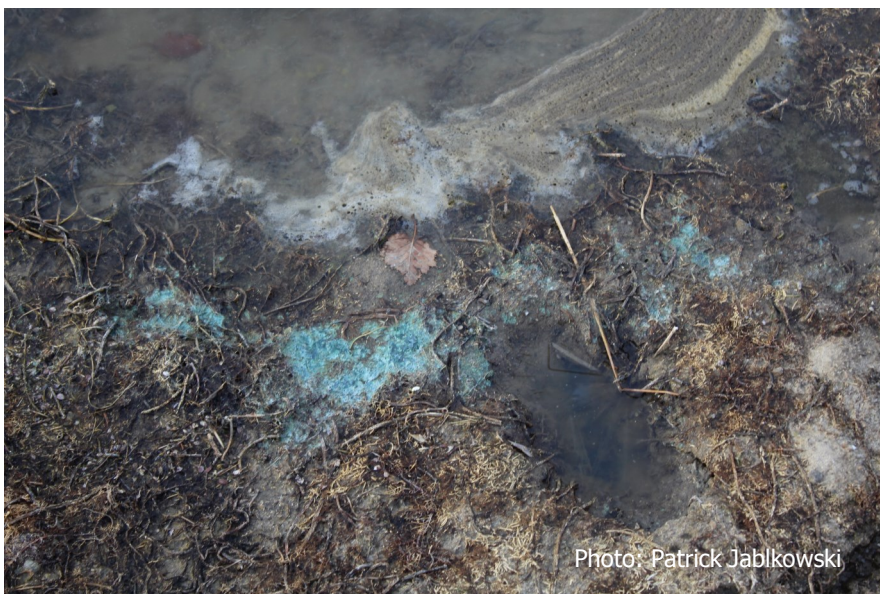
Blue-green algae (*Cyanobacteria*) can appear as floating mats in the water, or at the edge of the water. This photo was taken at the Bull-head Reservoir following a health advisory on October 5, 2017.

Accelerated nutrient enrichment of lakes and reservoirs (often by phosphorous), leads to the condition called **eutrophication**. This condition promotes the growth of blue-green algae (*Cyanobacteria*) that can release toxin into the water,
