# Aerial Assessment of Riparian Areas in the Seven Persons Creek Watershed

Summary October 2018

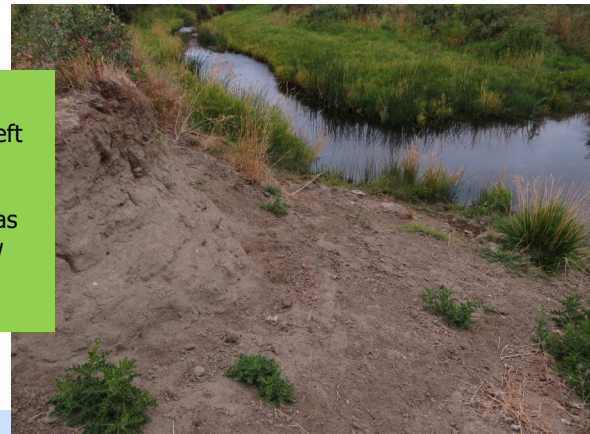
In the adjacent photo, the riparian area on the immediate left was designated as **Unhealthy** with little woody vegetation, exposed bare soil, and a high degree of incisement from erosion. The riparian area to the upper right was classified as **Healthy** with a moderate amount of woody vegetation, low slope, and good asymmetry.
