# AERIAL ASSESSMENT OF RIPARIAN AREAS IN THE SEVEN PERSONS CREEK WATERSHED, AB

Final Report

For: South East Alberta Watershed Alliance

Submission Date: May 4, 2018

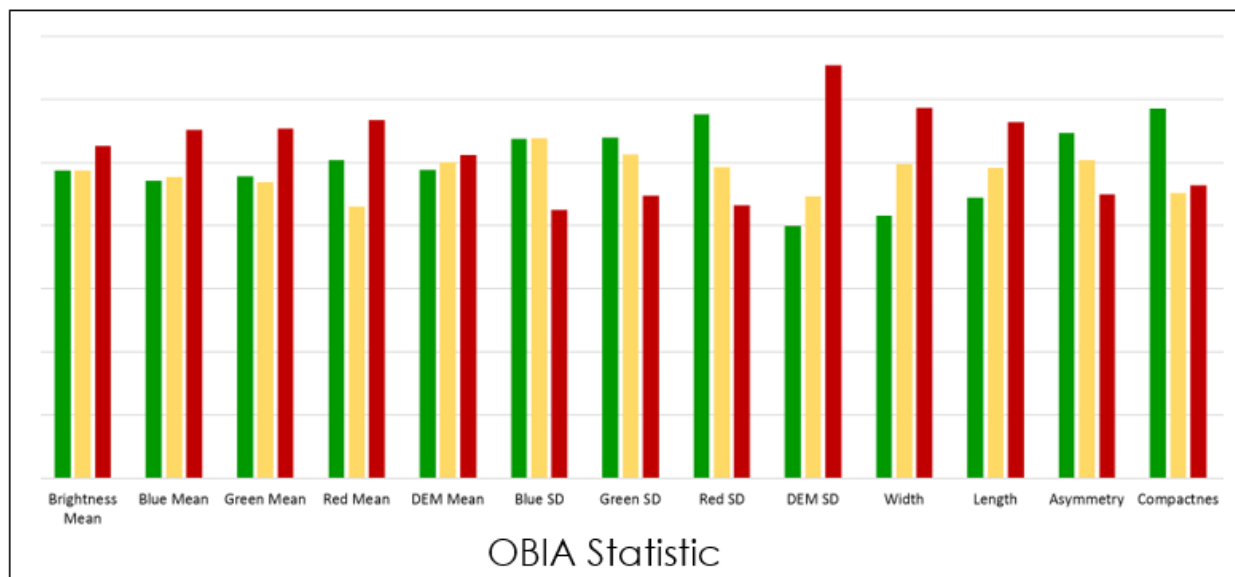
**Figure 6-1 Normalized Lotic Riparian Area Field Data OBIA Statistics Broken Down by Health Designation: Healthy (green), Healthy with Problems (yellow), Unhealthy (red). Class averages of Normalized Correlation Values to Lotic field data RHA scores**

**Figure 6-1** represents each lotic OBIA statistic separated by field RHA survey riparian health category normalized by overall OBIA statistic mean. The lotic brightness mean, blue mean, red standard deviation, DEM standard deviation and asymmetry OBIA statistics show a linear trend with RHA health scores. These linear trends explain the higher OBIA and RHA score correlations values for these OBIA stats as seen in **Table 6-4** above. The combination of higher correlation values and linear trend patterns demonstrate the five selected OBIA statistics have the most available lotic predictive riparian health modelling capability. As a result, these five OBIA statistics were used in the Riparian Health Model (RHM) to predict riparian health score for all remaining SPCW lotic riparian areas.

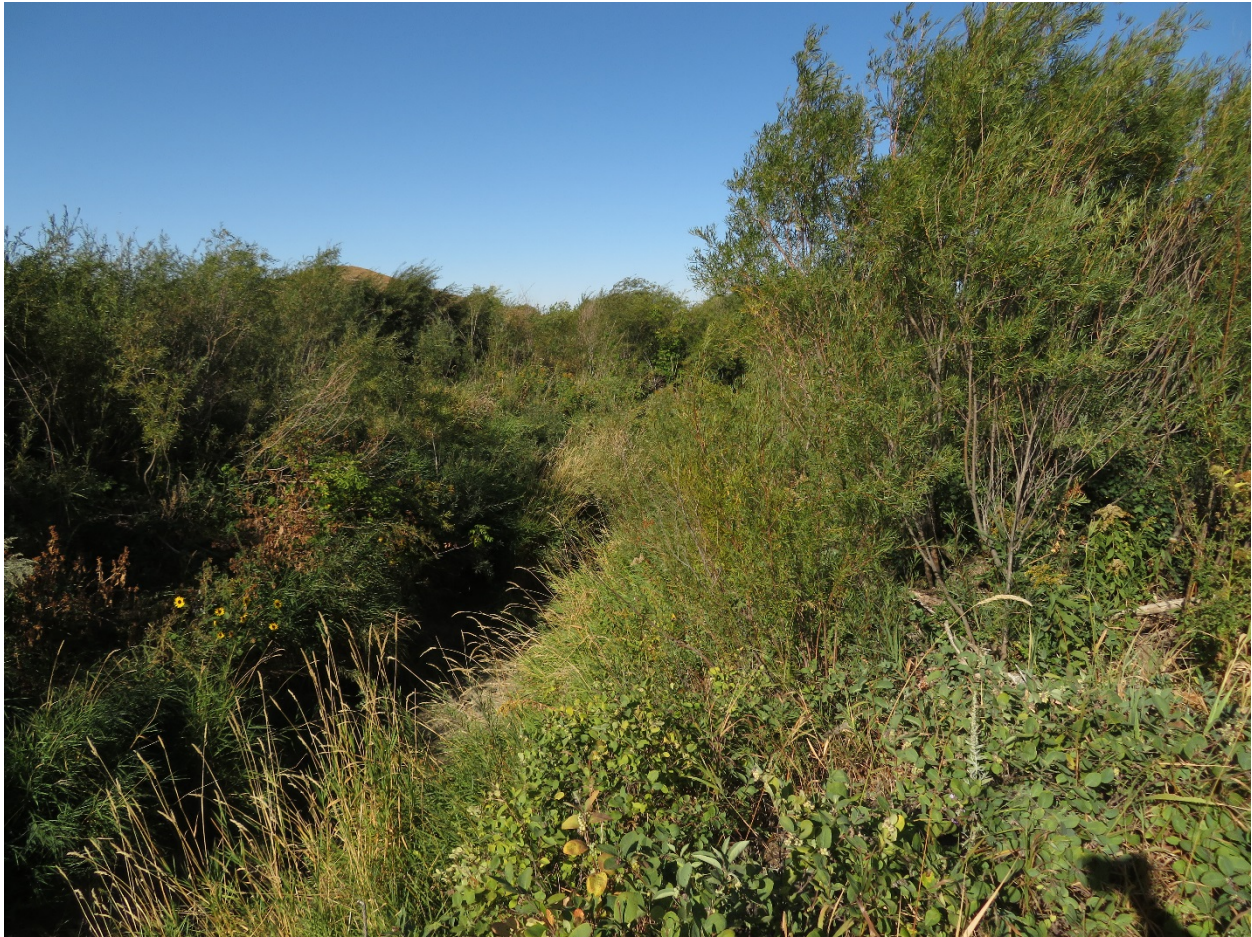
**Figure 1-1.** Riparian areas on both sides of the water body were classified as **Healthy** with a strong presence of shrub vegetation and the shape of the riparian area followed the natural meandering of the stream. These riparian areas had low brightness mean, blue mean values, high red standard deviation values and high asymmetry.

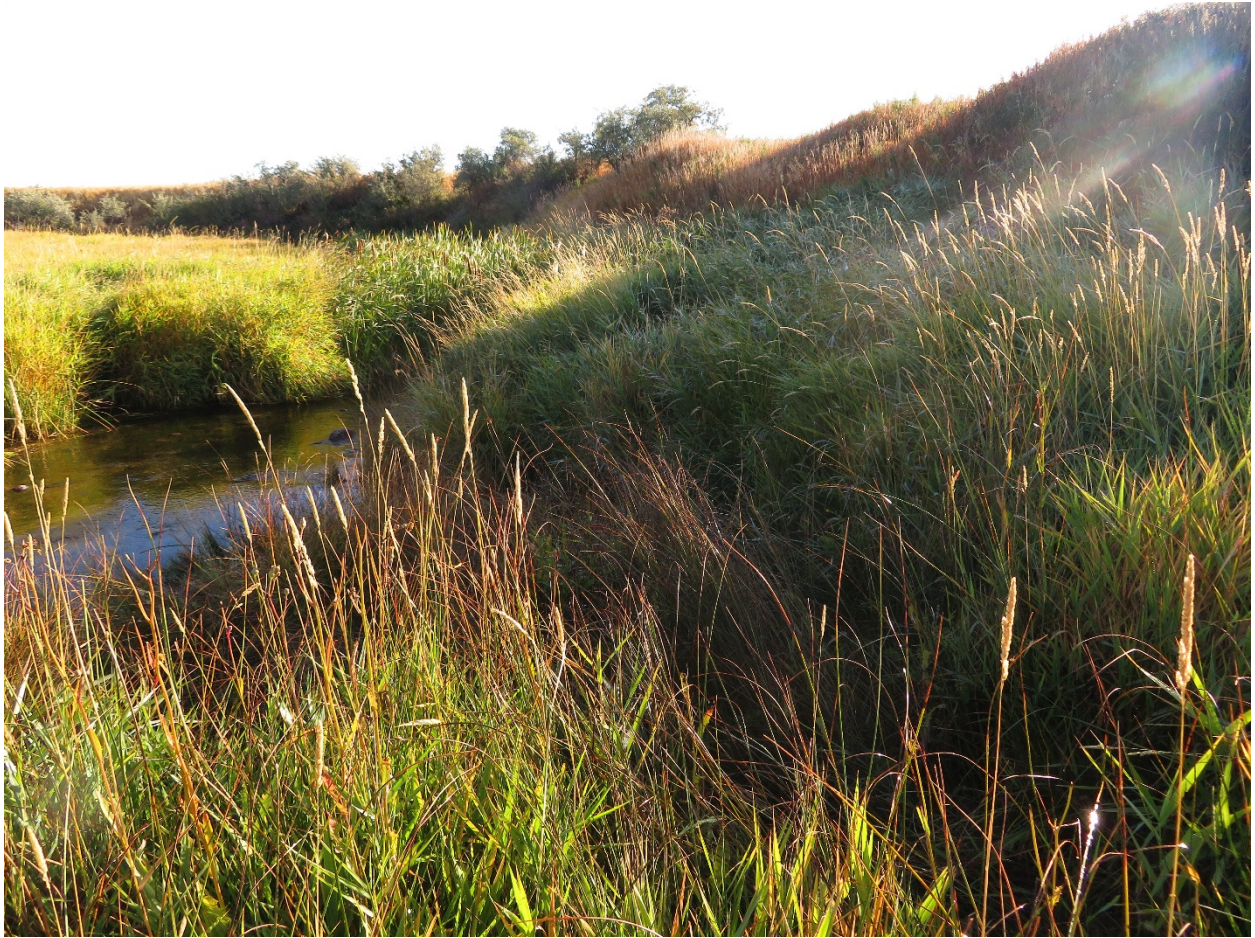
**Figure 1-2.** The riparian area on the immediate right was designated as **Unhealthy** with a lack of woody vegetation and a high degree of slope. This riparian area had high brightness mean, blue mean values, low red standard deviation low and high DEM standard deviation values.

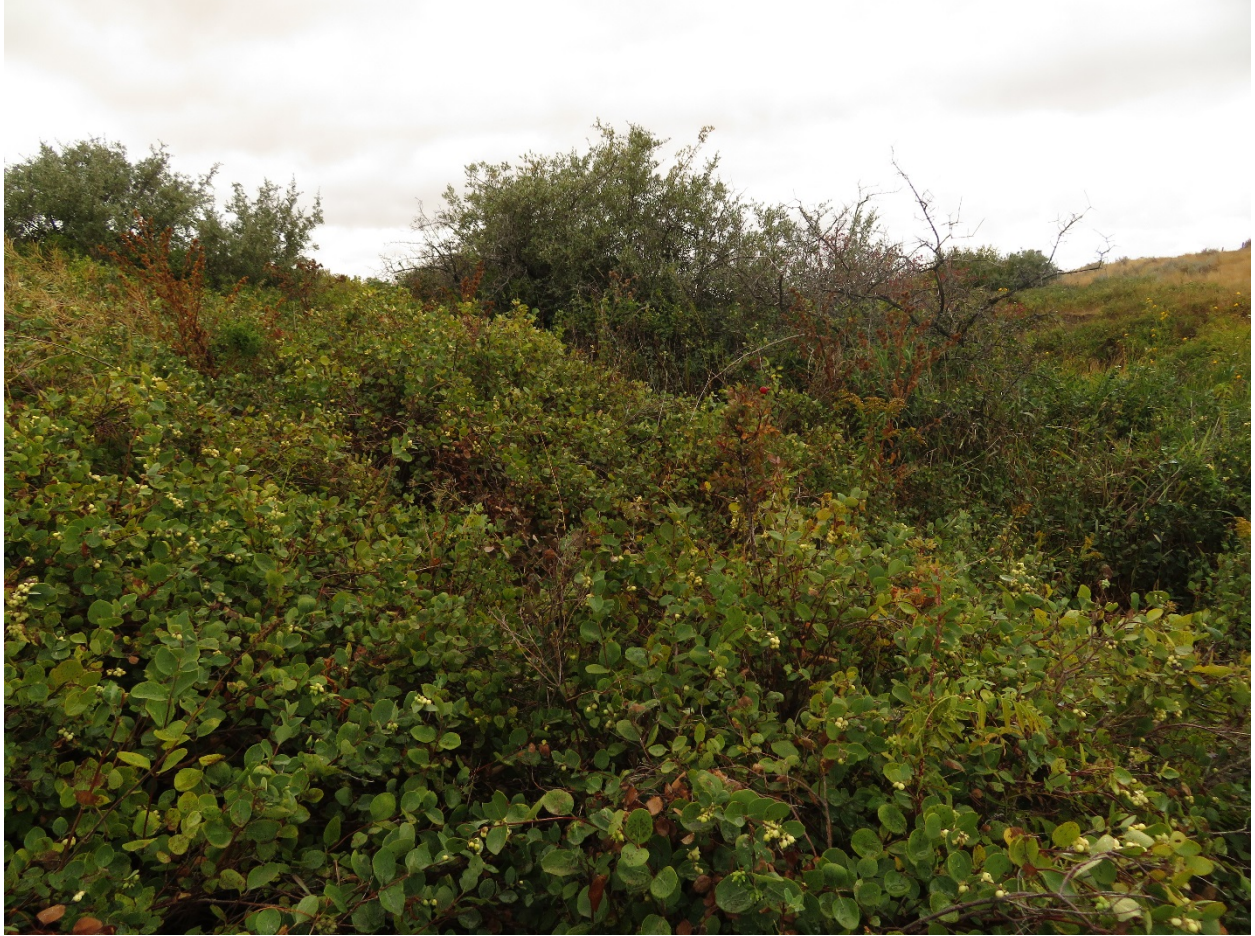
**Figure 1-3.** The riparian area on immediate left was designated as **Healthy with Problems (HWP)** with a moderate amount of woody vegetation and a high degree of slope. This riparian area had moderate brightness mean, blue mean, moderate red standard deviation values and high DEM standard deviation.

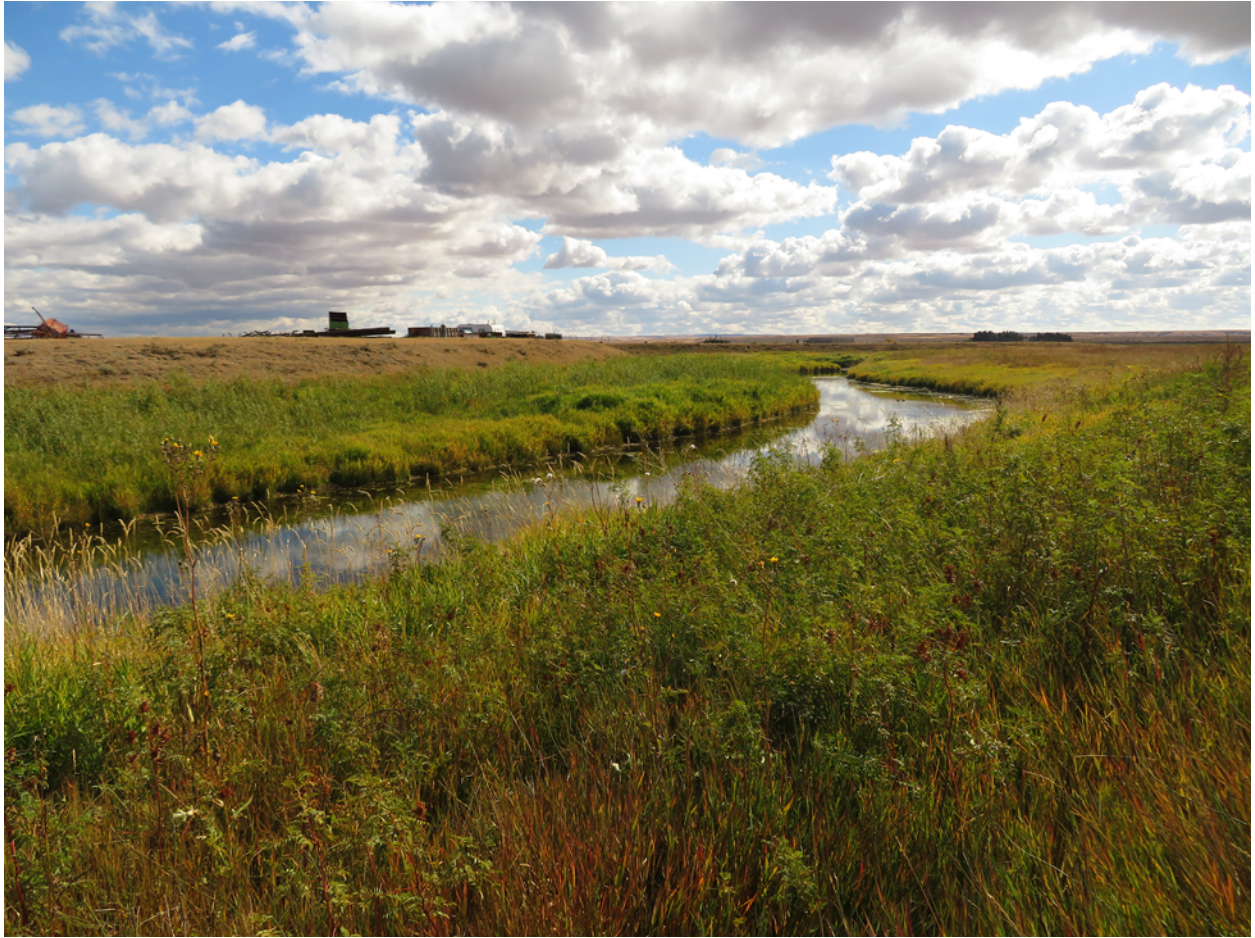
**Figure 1-4.** The riparian area on right was designated as **Healthy with Problems (HWP)** with a low to moderate amount of woody vegetation, a moderate degree of slope, and high asymmetry with the water course. This riparian area had low to moderate brightness mean, blue mean values, moderate red standard deviation values, moderate DEM standard deviation and high asymmetry values.

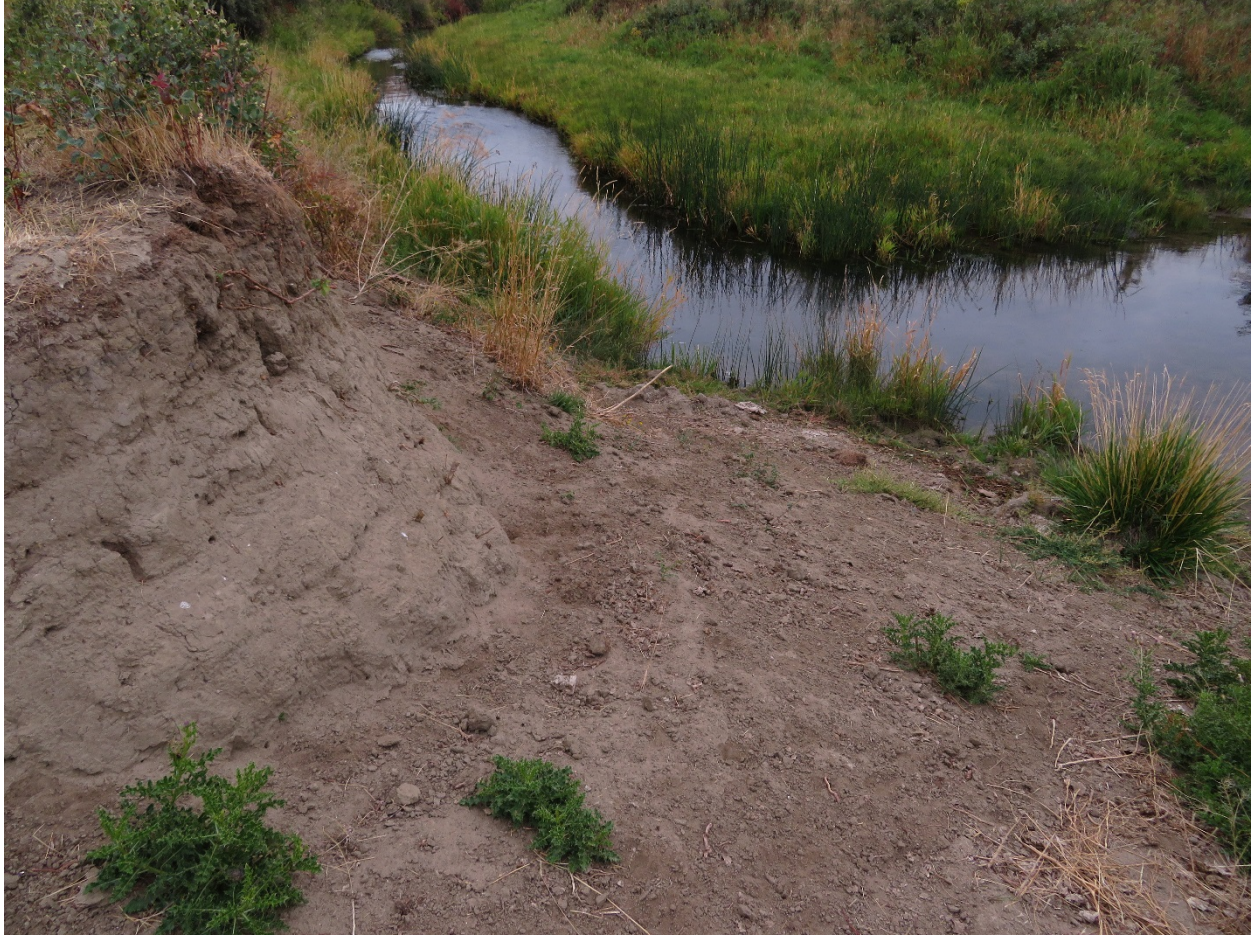
**Figure 1-5.** The riparian area on immediate left was designated as **Unhealthy** with a little woody vegetation, exposed bare soil, a high degree of incisement from erosion. This riparian area had extremely high brightness mean, blue mean values, low red standard deviation from lack of vegetation and high DEM standard deviation from incisement issues. The riparian area in the upper right was classified as **Healthy** with a moderate amount of woody vegetation, low slope, and good asymmetry. This riparian area had low brightness mean, blue mean values, high red standard deviation, low DEM standard deviation, high asymmetry values.

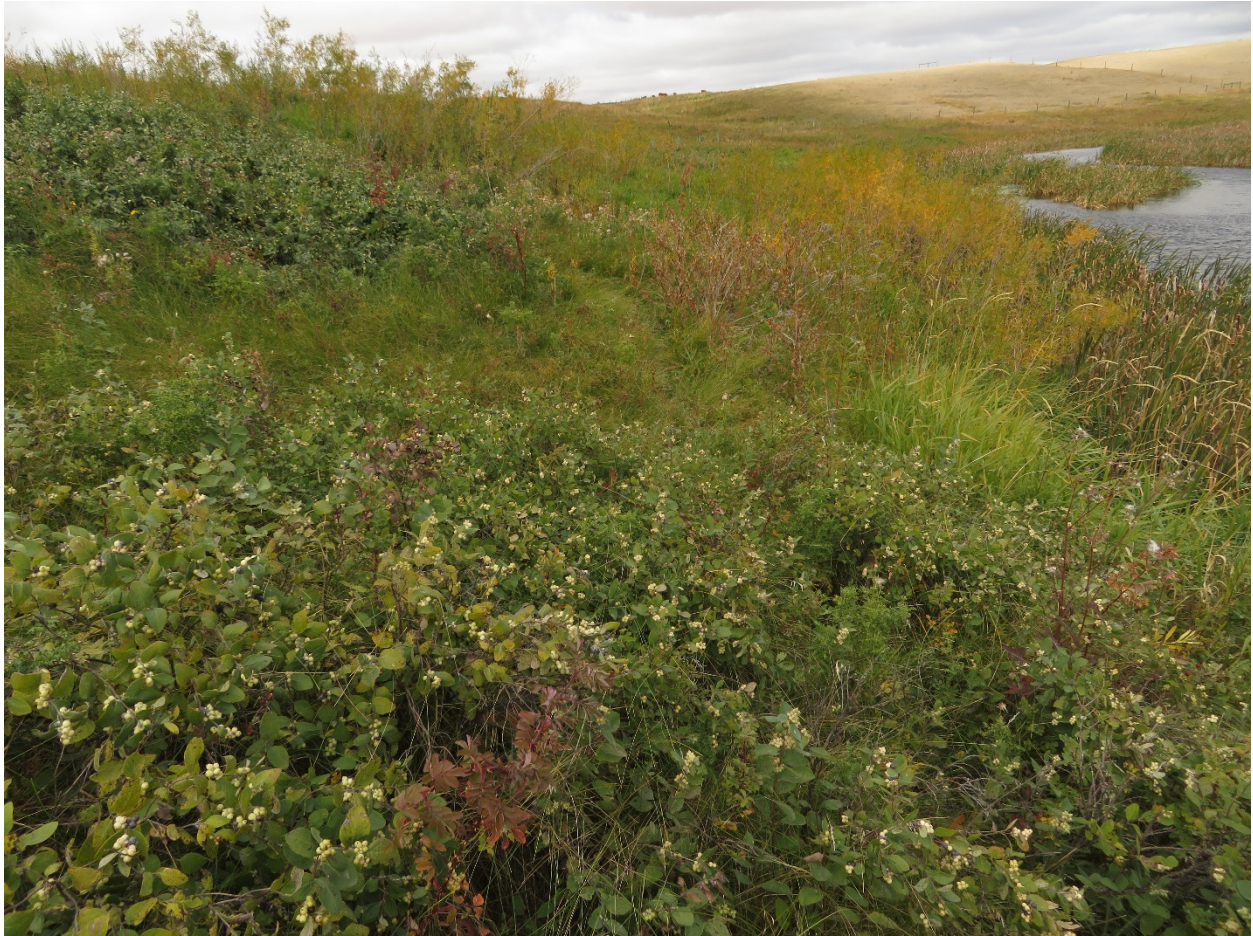
**Figure 2-1.** This lentic riparian area was categorized as **Healthy** with a high degree of naturally occurring vegetation cover, moderate amount of slope and has natural asymmetry to the water body without being compact. Vegetation captured by low blue and green mean OBIA statistic values covered greater than 95% of the reach soil surface and was unaltered by human activity indicating good riparian health. High asymmetry and low compactness readings indicate the riparian area's physical outline was not impact by human activity.

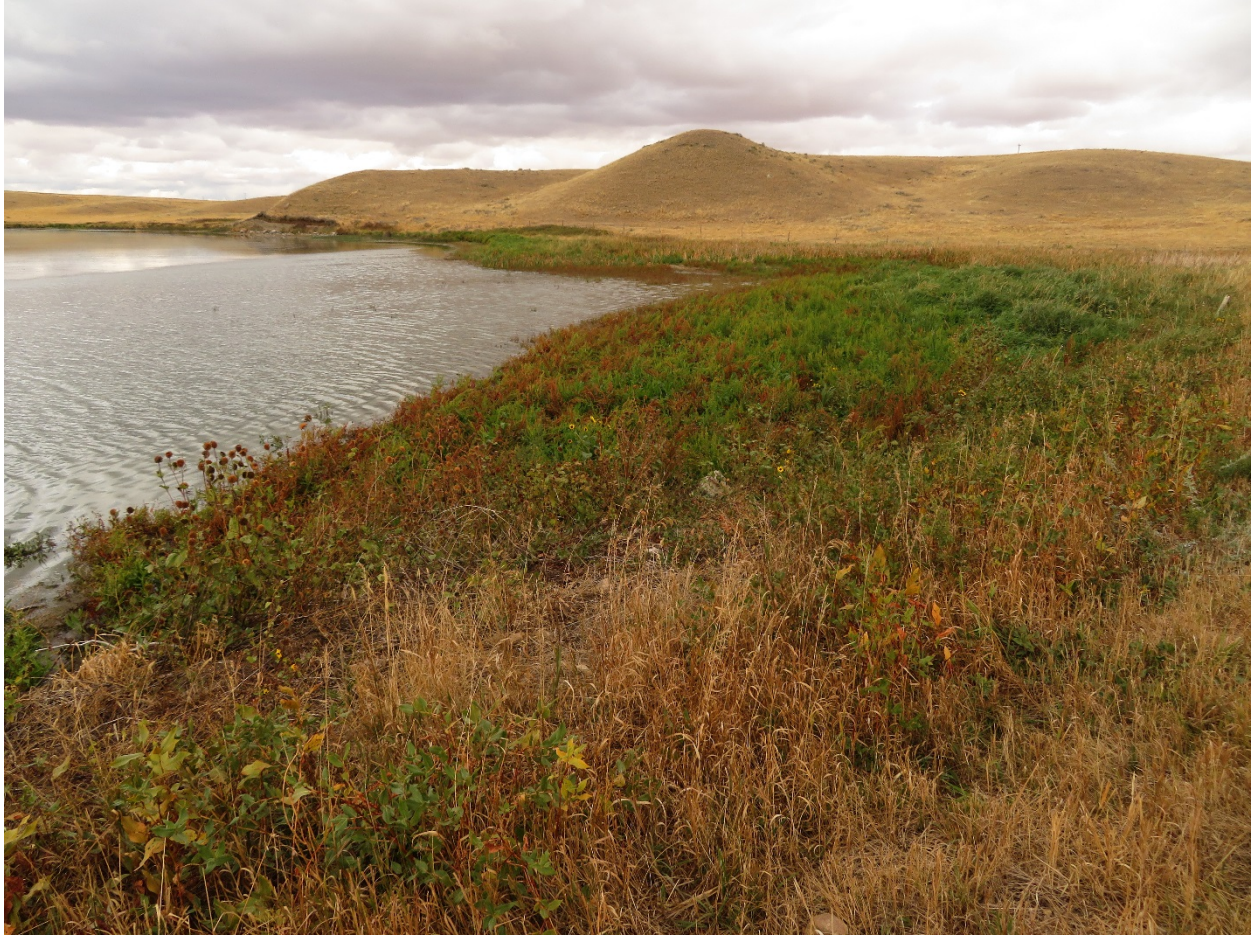
**Figure 2-2.** This lentic riparian area was classified as **Healthy with Problems** with a moderate amount of naturally occurring vegetation cover, lowered amount of slope and had natural asymmetry to the water body without being compact. Vegetation captured by average blue and green mean OBIA statistic values covering much of the reach soil surface and was unaltered by human activity. High asymmetry and low compactness readings indicate the riparian area's physical outline was not impact by human activity. This riparian area lacked denser vegetation and greater slope to be considered healthy.

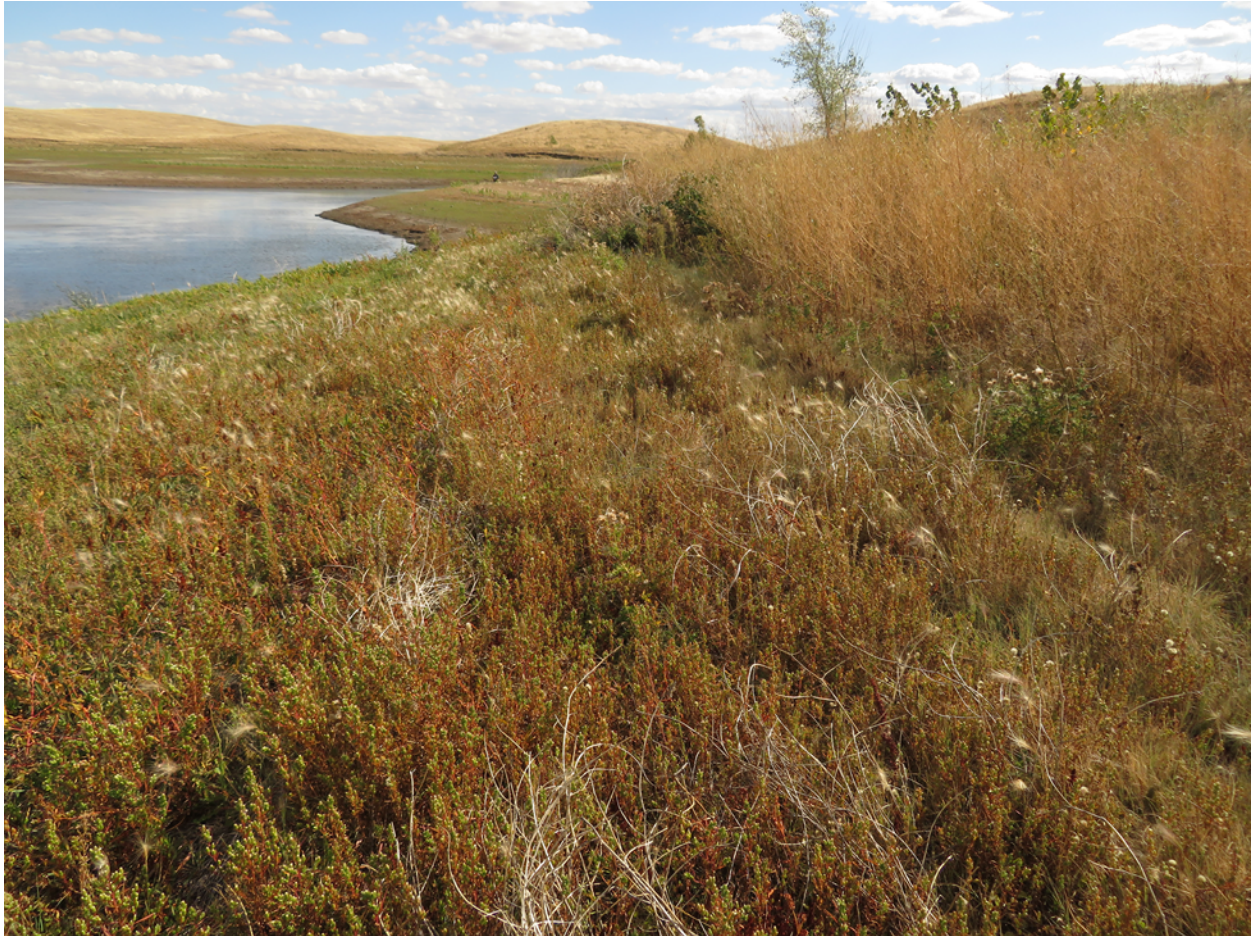
**Figure 2-3.** This lentic riparian area was designated as **Healthy with Problems** with moderate to low amounts of vegetation cover, moderate amount of slope and had meandering asymmetry to the water body without being compact. Vegetation was lacking near shoreline with exposed soils and only short grass in other areas. This may be caused by grazing or mowing of vegetation or altering of water body levels. This was captured by moderate to high blue and green mean OBIA values. High asymmetry and low compactness readings indicate the riparian area's physical outline was not impact by human activity. This riparian area lacked denser vegetation to be considered healthy.

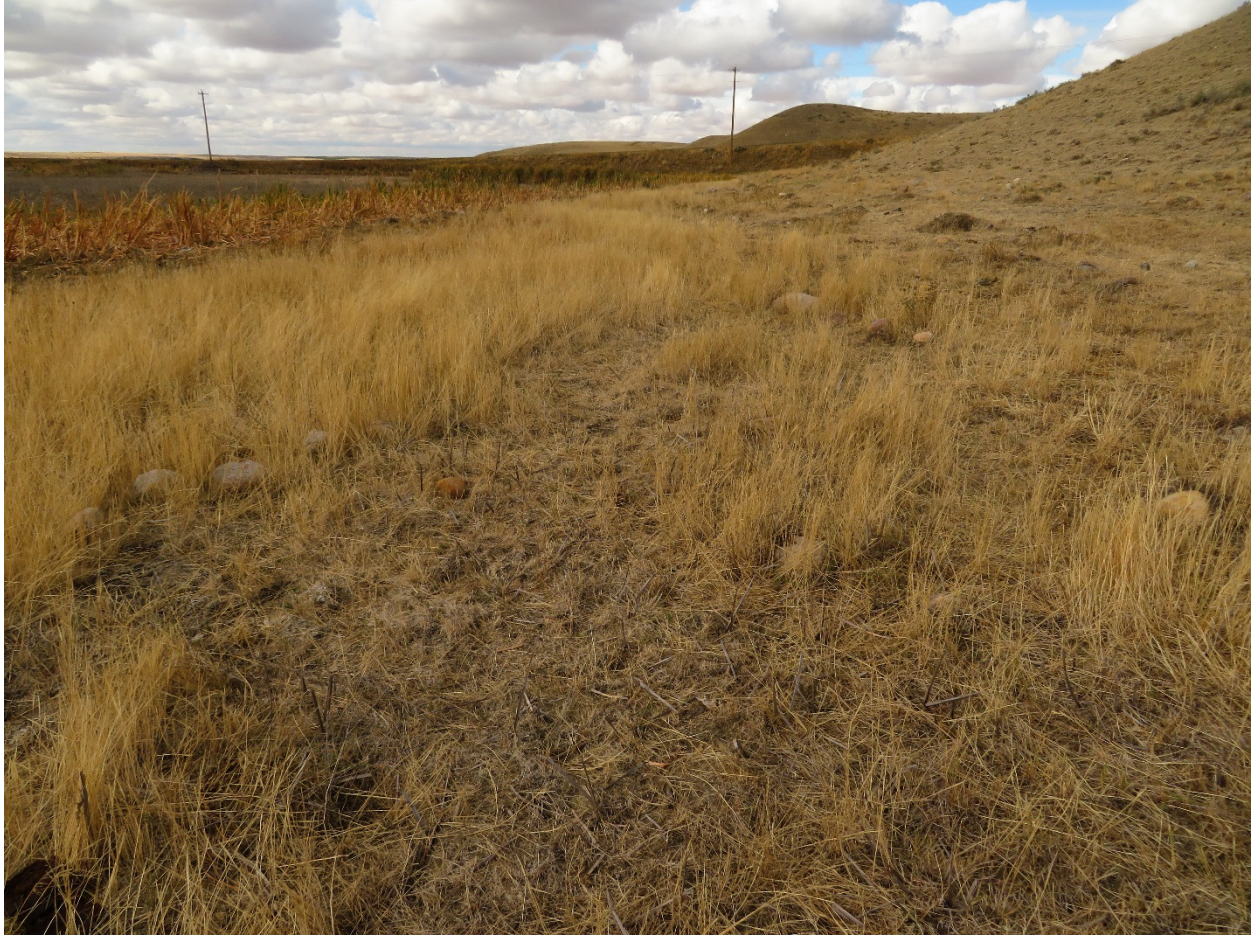
**Figure 2-4.** This riparian area was classified as **Unhealthy** with a poor vegetation canopy, moderate slope, and moderate asymmetry and compactness values. High blue and green mean values indicate a low amount of naturally occurring vegetation and is an indication of hayland\pasture usage. The moderate asymmetry and compact shape of the riparian area's outline indicates an impact from human activities.
